MARSHWOOD DAM

NDI ID No. PA-00365
DER ID No. 35-88

⑥ PHASE I INSPECTION REPORT

① Number 12 1052 Number
NATIONAL DAM INSPECTION PROGRAM. Marshwood Dam
(NDI ID PA-00365, DER ID 35-88), Susquehanna River
Basin, Little Roaring Brook, Lackawanna
County, Pennsylvania

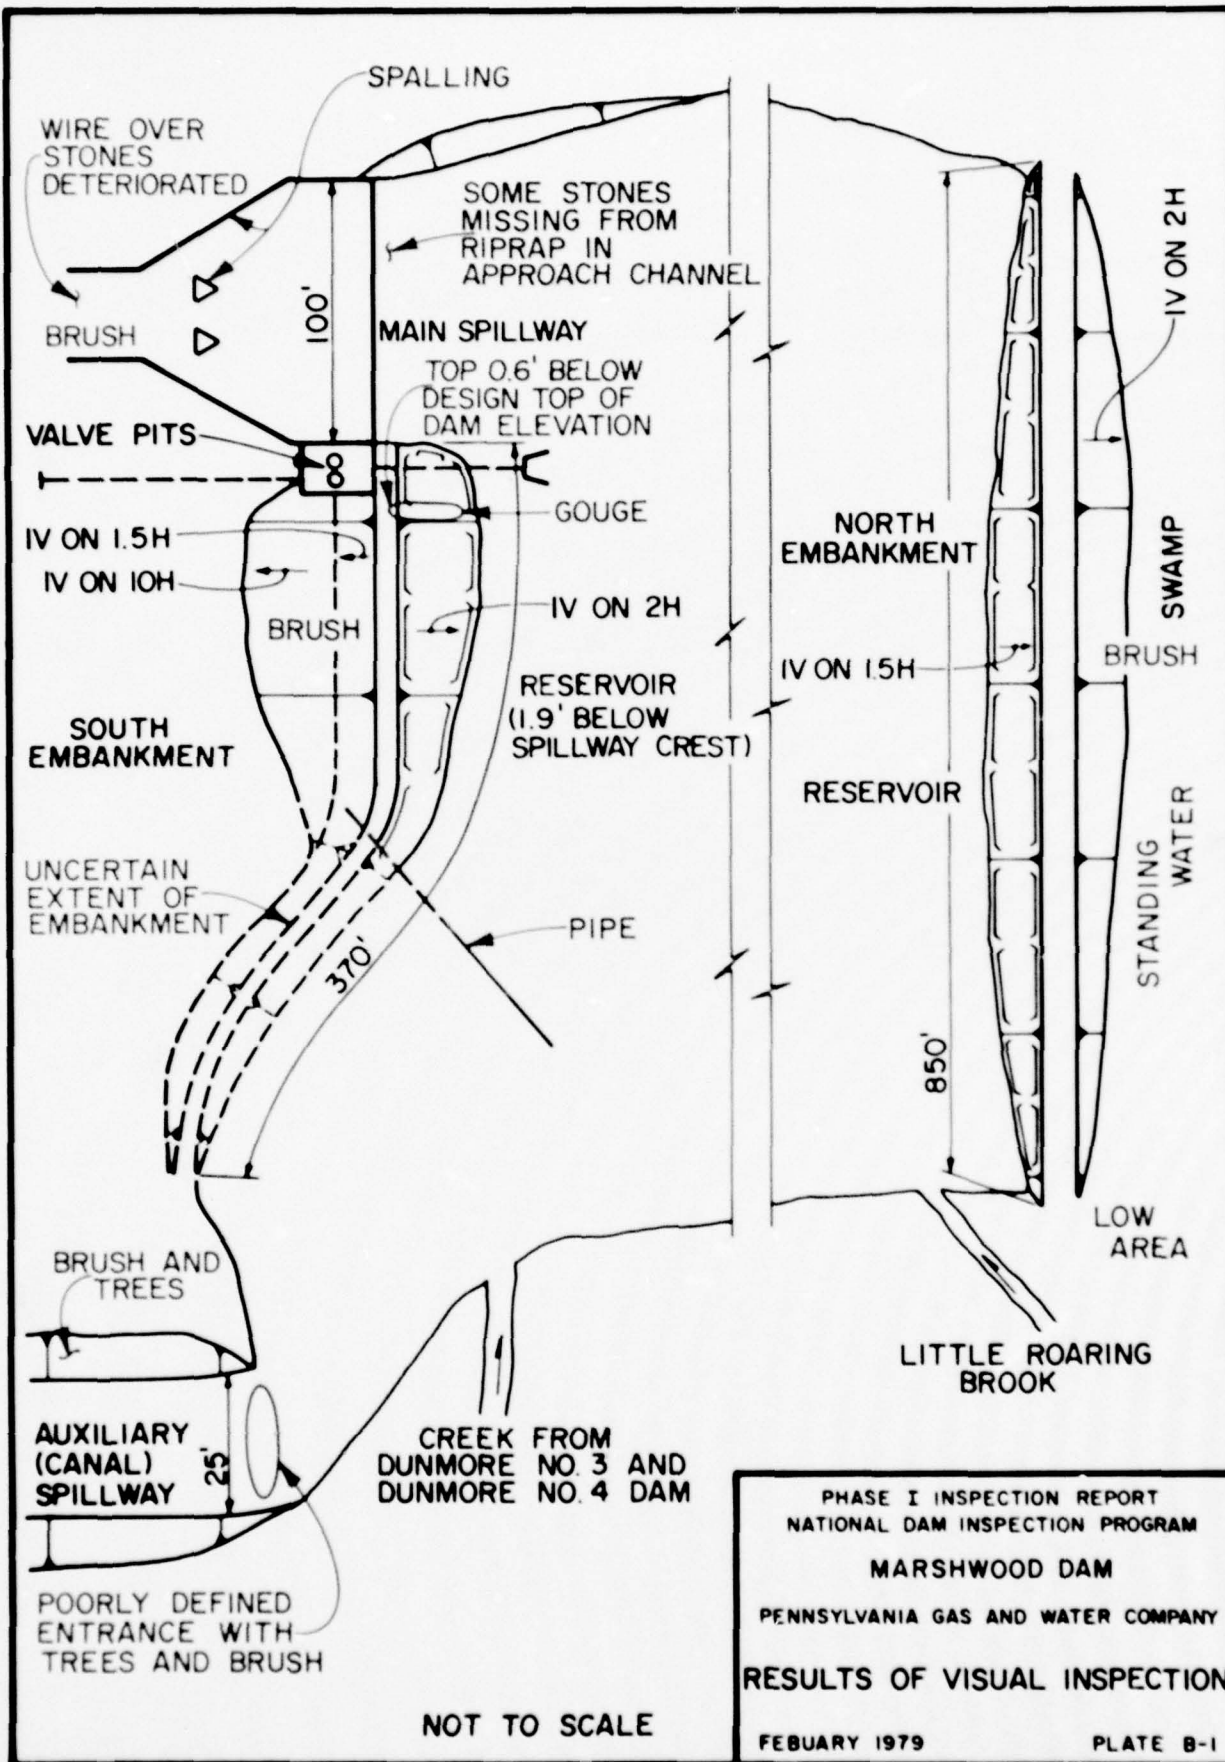
PHASE I INSPECTION REPORT
 NATIONAL DAM INSPECTION PROGRAM
 MARSHWOOD DAM
 PENNSYLVANIA GAS AND WATER COMPANY
 RESULTS OF VISUAL INSPECTION
 FEBRUARY 1979
 PLATE B-1

a. General. The overall appearance of the dam was fair, with some deficiencies as noted herein. The locations of some of these deficiencies are shown in Appendix B on Plate B-1. Survey data acquired during this inspection is presented in Appendix B. On the day of the inspection, the pool was 1.9 feet below the spillway crest elevation. The pool was being drawn down to fill Dunmore No. 1 Reservoir downstream.

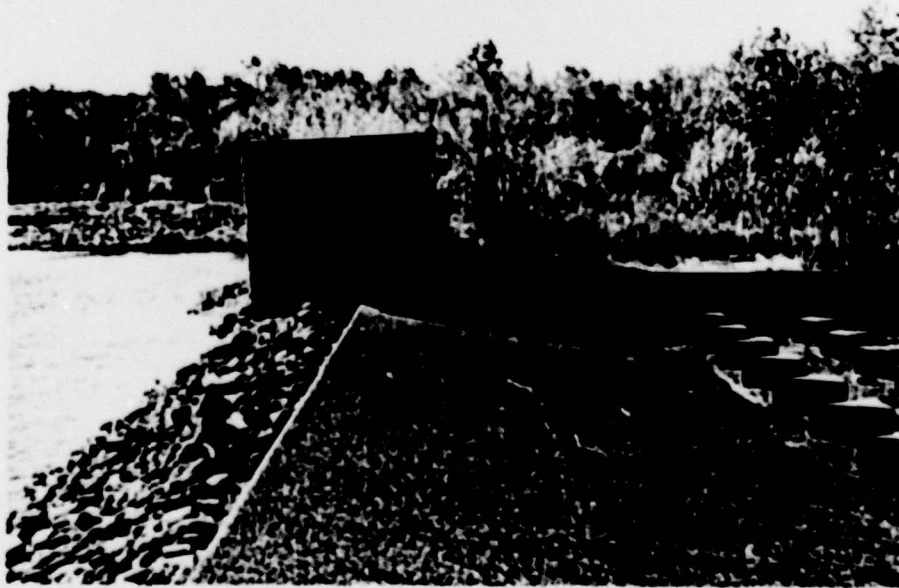
B. Main Spillway

The main spillway is in fair condition. In the approach channel, some of the riprap has been dislodged near the weir. There is severe spalling on some of the baffle blocks and on three areas of the wall. Downstream of the stilling basin, the wire mesh that once contained the stone protection is completely pulled away from the stones. The downstream channel is overgrown.

(4) Appurtenant Structures. The spalling in the main spillway concrete is probably caused by long term exposure to the elements.

(6) Repair the concrete in the stilling basin.

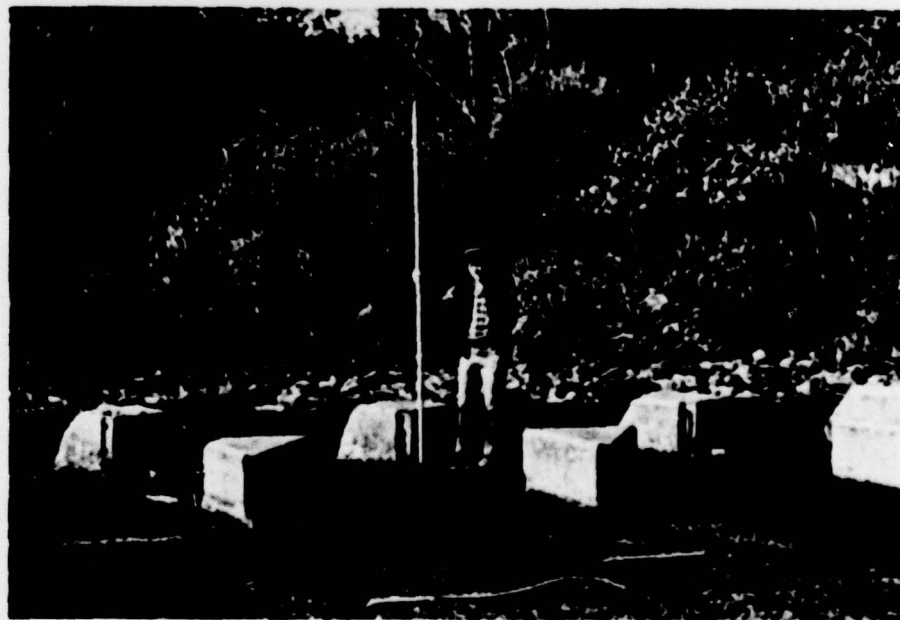
D. Spillway Outlet Channel

d. Appurtenant Structures. The condition of the wire mesh at the main spillway channel indicates an erosion hazard exists downstream of the stilling basin. The brush in this channel will raise tailwater. This will not cause a backwater effect on the weir, but it may cause overtopping of the channel banks, which would be an erosion hazard for sustained flows in the main spillway. The dislodged riprap upstream of the weir may have been caused by ice floes.

(2) Remove brush and trees that are in the main spillway outlet channel and that are on or near the embankment. When the brush and trees are removed, the embankment should be inspected on a regular basis to check for wet areas or seepage. After the brush is removed, the embankments should be inspected in detail to determine if any deficiencies exist. Take appropriate action as required.

(5) Repair the wire mesh in the main spillway outlet channel and the riprap in the approach channel.

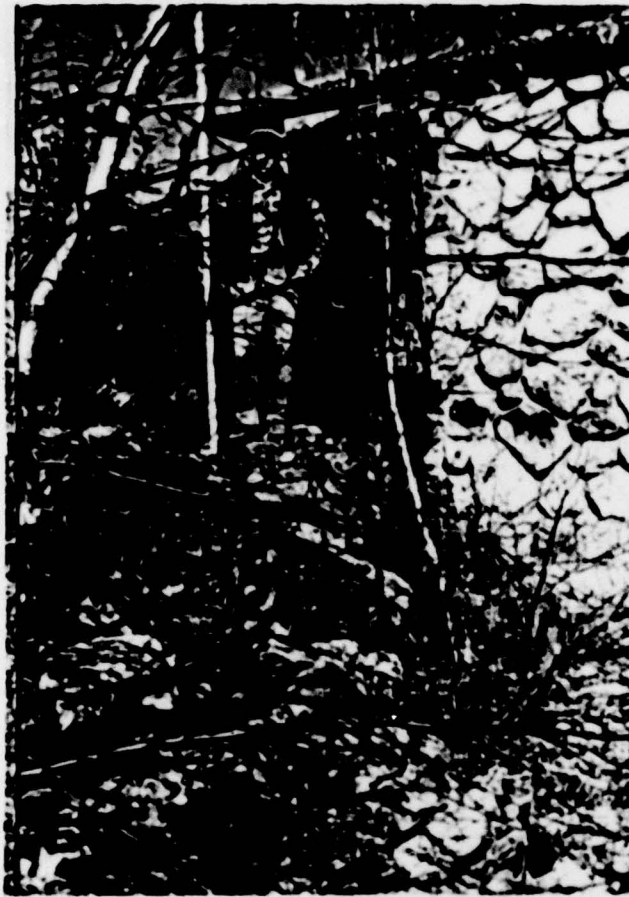
E. Gouge in South Embankment

VISUAL EXAMINATION OF	OBSERVATIONS	REMARKS OR RECOMMENDATIONS
SURFACE CRACKS	NONE	
UNUSUAL MOVEMENT OR CRACKING AT OR BEYOND THE TOE	NONE	
SLOUGHING OR EROSION: Embankment Slopes Abutment Slopes	FOR A 10' LENGTH NEAR VALVE HOUSE THERE IS A GOUGE. TOPWATER IS 50% OF NORMAL HERE.	EMBANKMENT IS SANDY SILT.
CREST ALIGNMENT: Vertical Horizontal	SEE SURVEY DATA SHEETS FOLLOWING INSPECTION FORMS.	
RIPRAP FAILURES	SEE SLOUGHING. ALSO 2 AREAS WITH GRASS ERODED.

(3) Repair the gouge on the South Embankment.
